Manhole Inspection Summary

Manhole # S15CC2014MH

Insp Date: **8/9/06 12:00 AM**

Location Address: **2111 SULGRAVE AVE**

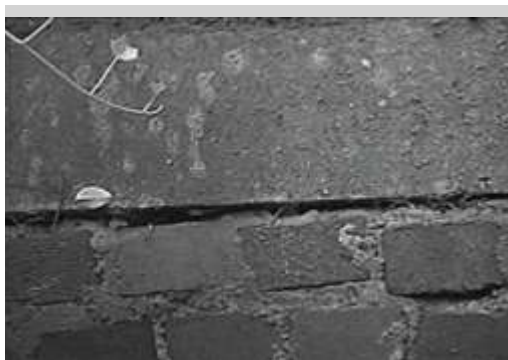
Defect

☒ **Leaks**

Infiltration: ☐ None ☒ **Joint** ☐ Cracks ☒ **Mortar** ☐ Roots ☐ Wall

Frame leaks. Adjustment infiltration.

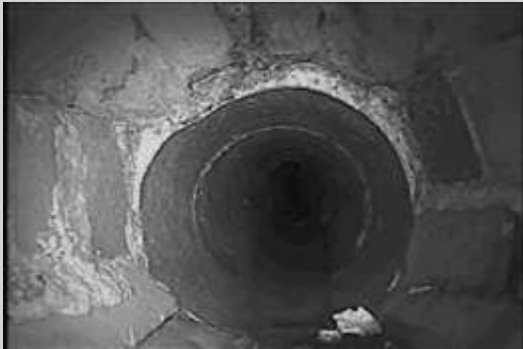
8 in. Circular Gravity Sewer Pipe Out @ 12 O'Clock

Infiltration: **Evidence** Pipe Seal Cond: **Unknown**

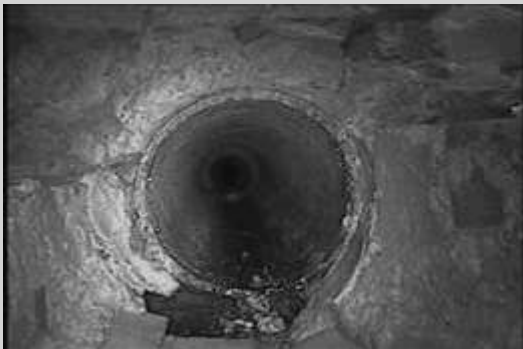
6 in. Circular Gravity Sewer Pipe In @ 5 O'Clock

Channel deterioration.

Deposits: ☐ None ☐ Mud ☐ Sludge ☒ Debris ☒ Grease

Infiltration: **Evidence** Pipe Seal Cond: **Cracked**
